Something NEW Under the Sun

Take a tour of the newest research in pavements and materials presented at the 88th meeting of the Transportation Research Board.

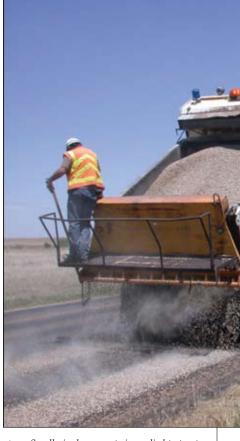
Small-sized aggregate is applied to treat a bleeding chip seal

The basic approaches used to treat bleeding include bridging over the live asphalt by applying aggregate of various types and gradations, cooling off the pavement surface by applying water with or without additives, or removing the bleeding asphalt and rebuilding the pavement seal.
