ROADS&BRIDGES

Able to reconnect

Warm mix plays big role in Colo. flood recovery

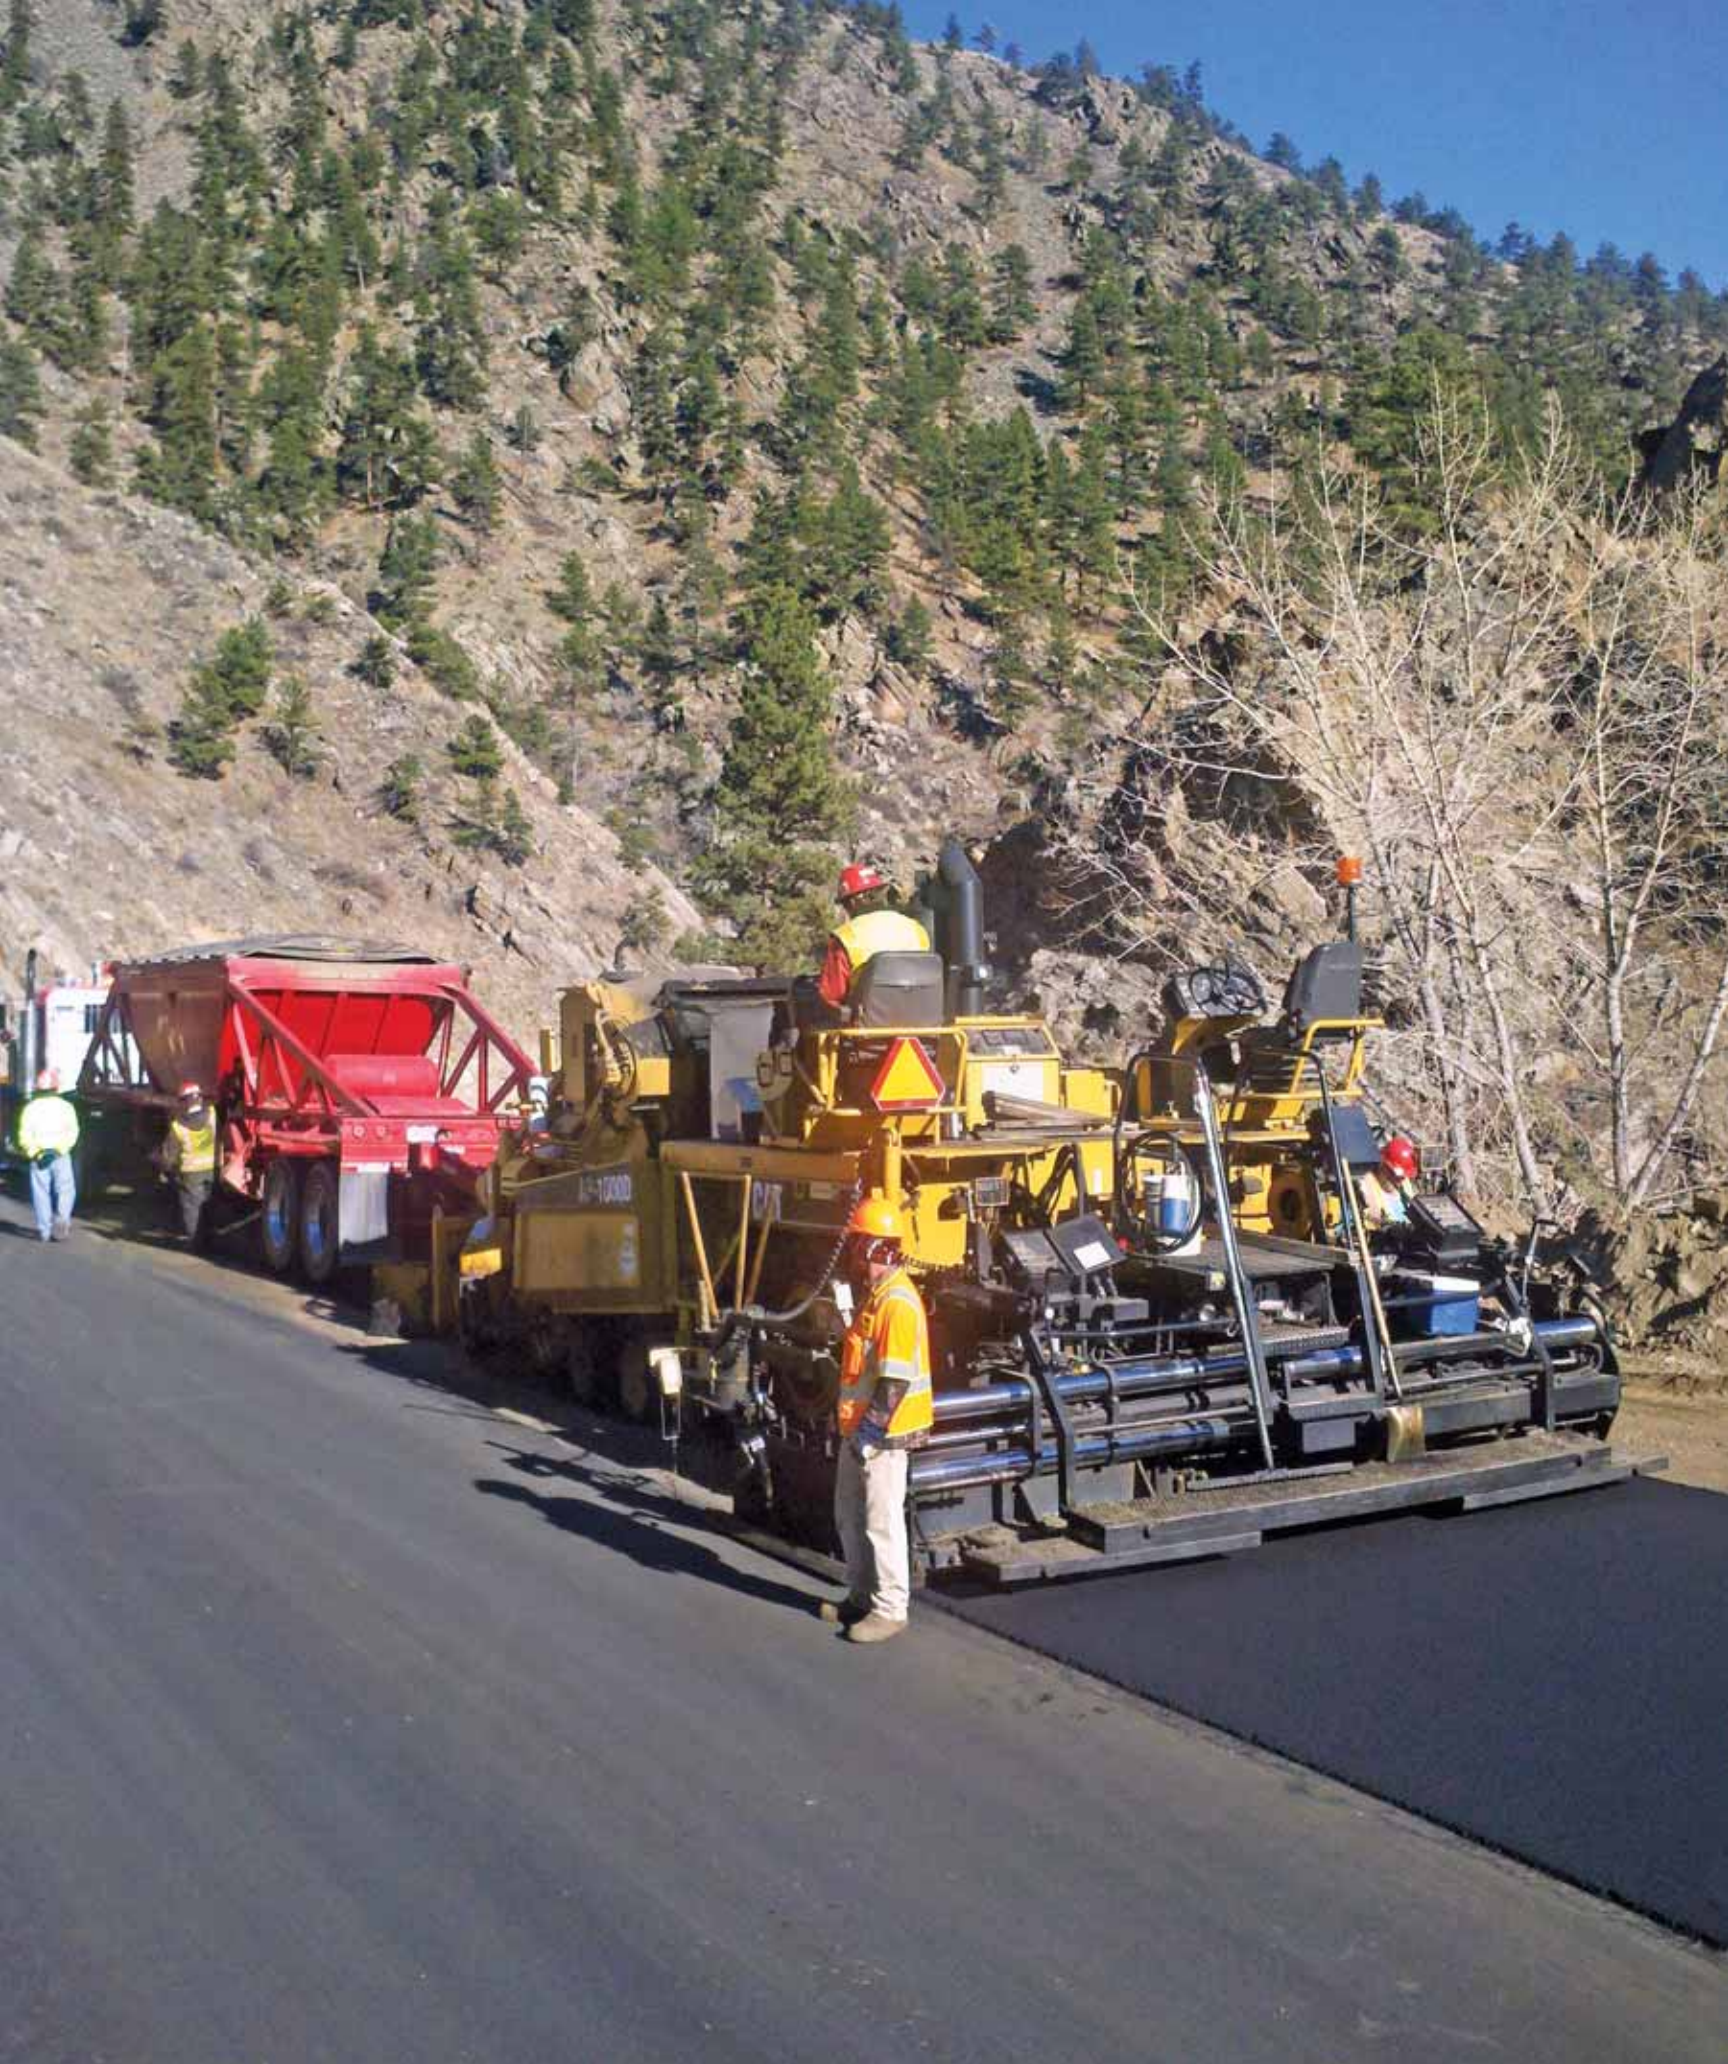
The effort to provide temporary road repairs to reopen access to homes and towns before winter was daunting. The last major highway was reopened in November. Photo courtesy of MWV Evotherm.

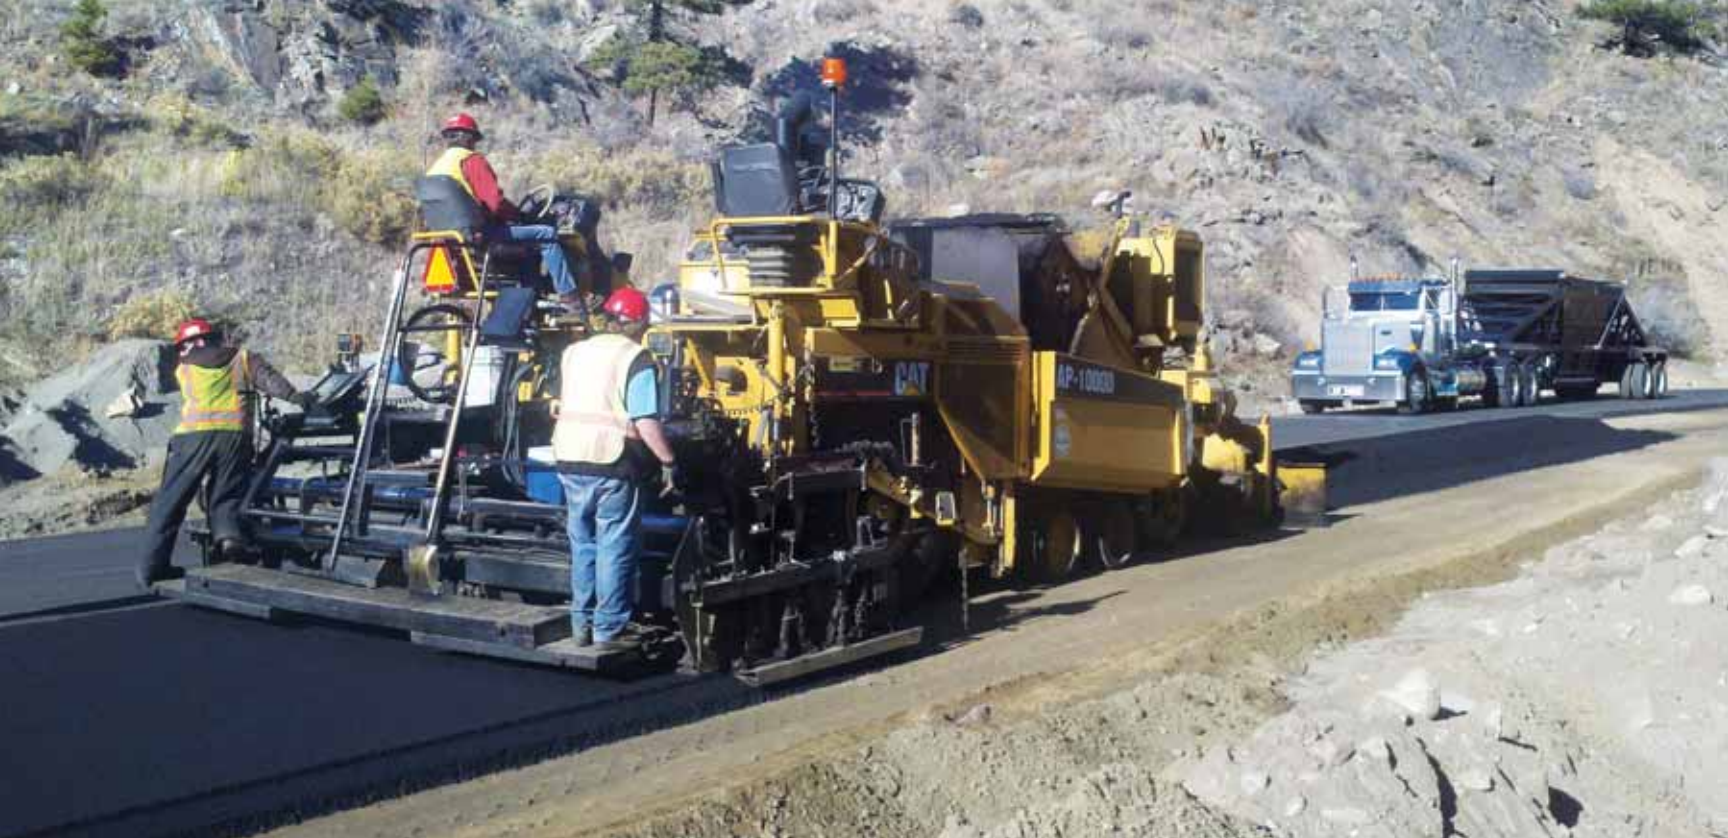
To maintain asphalt workability, forces of Coulson Excavating pave U.S. 34 between Loveland and Estes Park with warm-mix asphalt due to long hauls of up to three hours, low ambient temperatures at the end of the season and high elevations. Photo courtesy of MWV Evotherm.

In some instances, long haul distances during which mixes would cool, low ambient temperatures due to high elevations, and work late in the paving season dictated use of warm-mix asphalt (WMA) to ensure workability. For example, WMA was used extensively

on reconstruction of U.S. 34 through Big Thompson Canyon.

"Warm mix has proved to be an aid in marginal-weather paving," Peterson said. "And up in those canyons, with the winds and high elevation in November, the marginal weather there is ideally suited for warm mix. It gives the contractor mixes that will stay workable while meeting the spec requirements. Evotherm warm-mix technology provided the quality and ability to place the material successfully in marginally cold weather."
