To Prevent Failure, Begin with Better Bases

**Fatigue cracking usually links
to inadequate road foundations**

FAILPROOF
roadbuilding I
Fatigue
Cracking

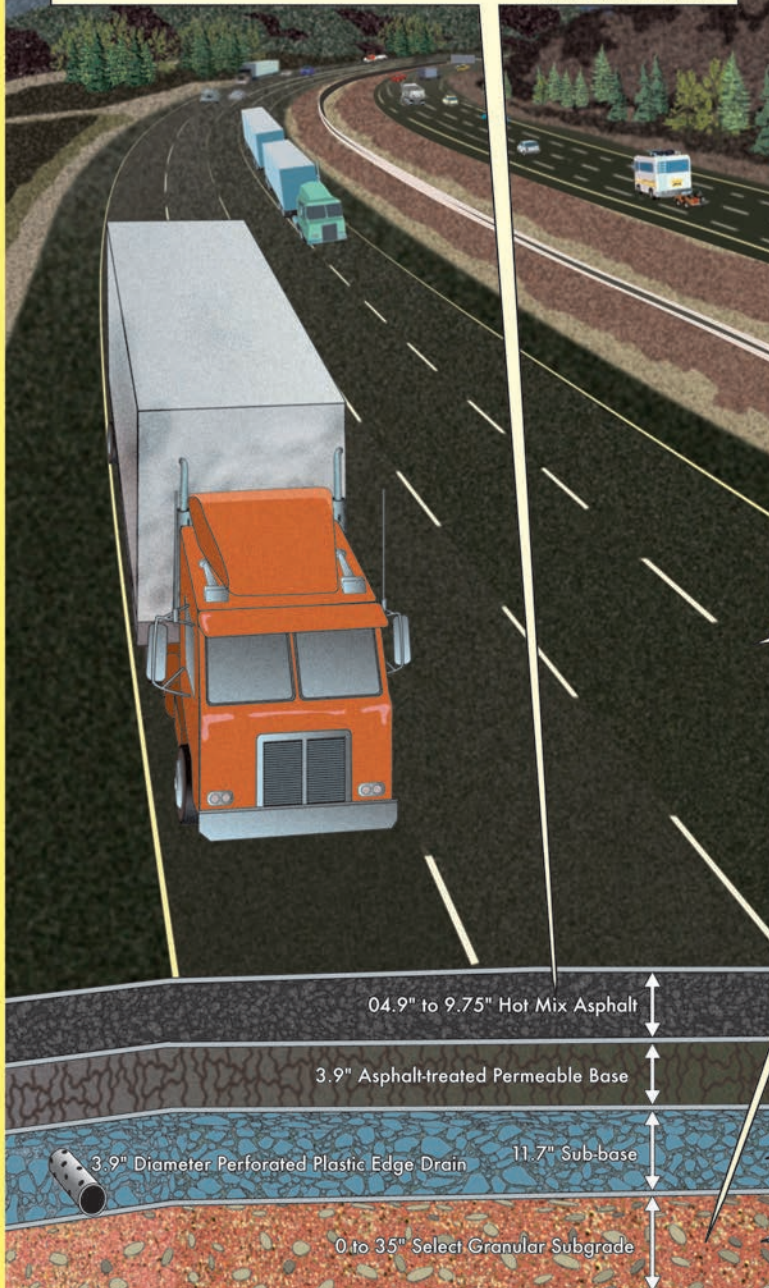
IMAGE CREDIT: NYSDOT

Fatigue cracking occurs when a bituminous pavement has been stressed to the limit of its fatigue life by repetitive axle load applications. But pavements with adequate depths of properly prepared layers can last indefinitely with periodic surface mill-and-overlays

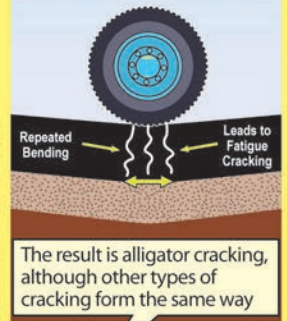
If inadequate substructure yields excessively under loading, repeated bending will result in cracks in lower layers migrating upward to surface course
IMAGE CREDIT: Rebecca McDaniel

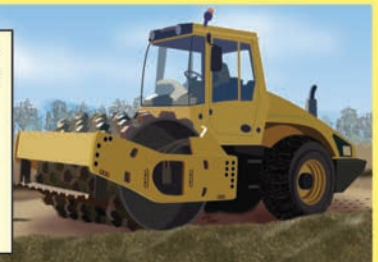
Compaction to-spec using padfoot rollers is essential to base layer performance that will result in long-lasting surface courses free of fatigue cracking

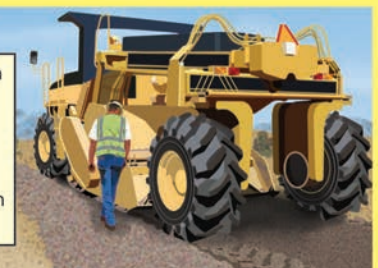
The ultimate solution is to build adequate substructures equal to the projected loads, including chemical stabilization when necessary

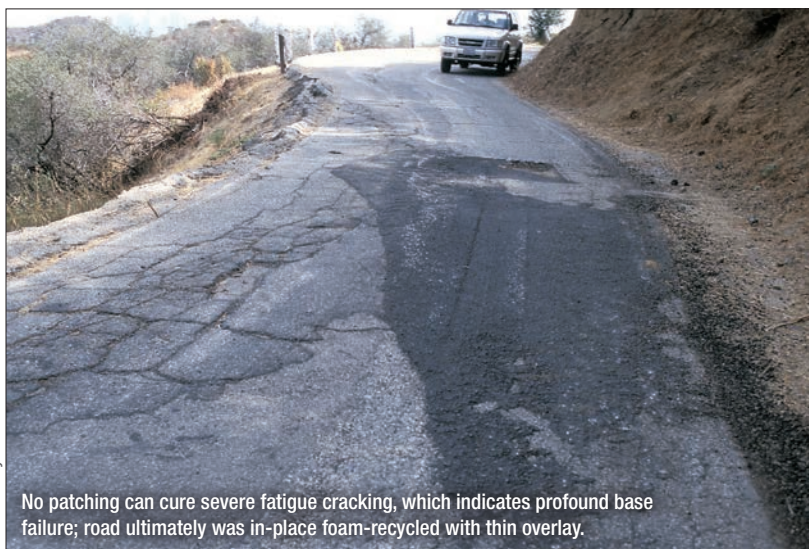
No patching can cure severe fatigue cracking, which indicates profound base failure; road ultimately was in-place foam-recycled with thin overlay.

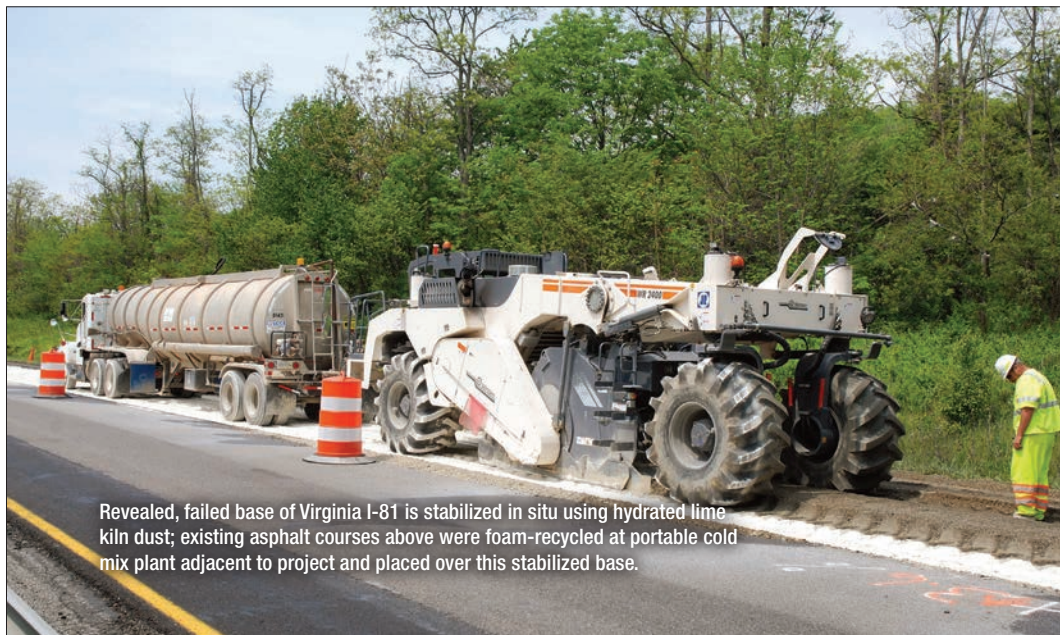
Revealed, failed base of Virginia I-81 is stabilized in situ using hydrated lime kiln dust; existing asphalt courses above were foam-recycled at portable cold mix plant adjacent to project and placed over this stabilized base.

In 2011 the Virginia Department of Transportation rebuilt a section of I-81 in the shadow of the Blue Ridge Mountains. Fatigue cracking, caused by years of heavy traffic loads, had deteriorated the pavement structure from bottom to top. While the symptoms of this deterioration could have been addressed by mill-and-overlay, VDOT says, the underlying condition would have remained, and the cause of this extensive wear could only be remedied

This section of I-81 was constructed in the late 1960s. VDOT routinely maintained the surface asphalt with periodic patching and overlays. However, the original foundation of compacted stone aggregate and soil had weakened to the point it no longer provided a stable base for the overlying asphalt layers.

The recycled foamed asphalt mix from the portable plant then was used to pave a new flexible base course over the restored subgrade to 6 inches compacted depth, later to be topped with a 4-inch intermediate course of conventional hot mix asphalt (HMA) and a 2-inch friction course of stone-matrix asphalt (SMA).
