# HIMA REDUCES STUDED TIRE WEAR RUTTING

**R**utting caused by studded tire wear is a problem in the American Pacific Northwest, costing the states of Oregon, Washington and Alaska millions of dollars annually in damage to asphalt and other roadways. The Alaska Department of Transportation and Public Facilities (DOT&PF) sponsored a study at the University of Alaska-Anchorage to estimate the costs of damage caused by studded tire wear to Alaskan highways. This included collecting data to determine the rate of rutting on different roadway classifications and for different vehicle types.

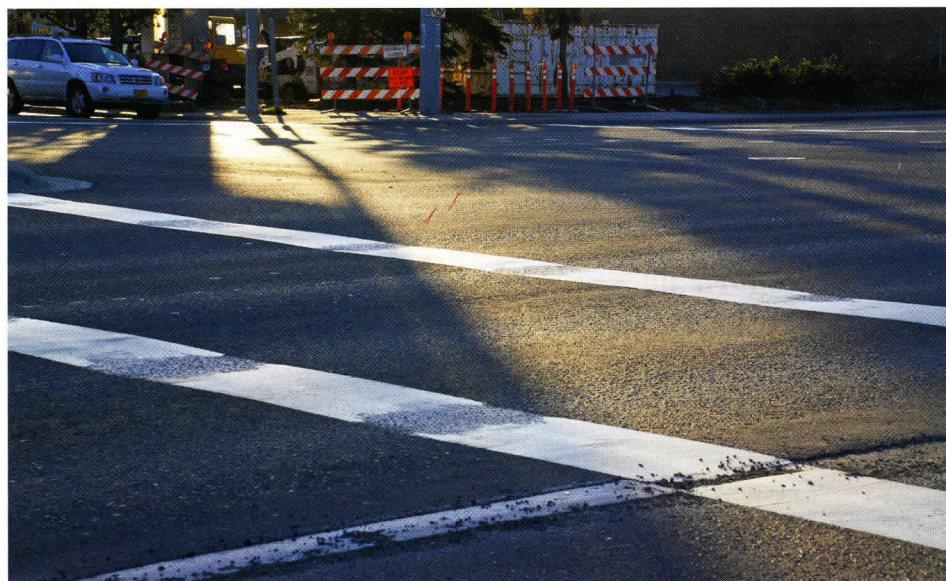
Undulating transverse shadows across rutted pavement—and gouged intersection striping—show rut damage caused by studded tires on Minnesota Avenue in Anchorage. *Photos courtesy of Kraton*

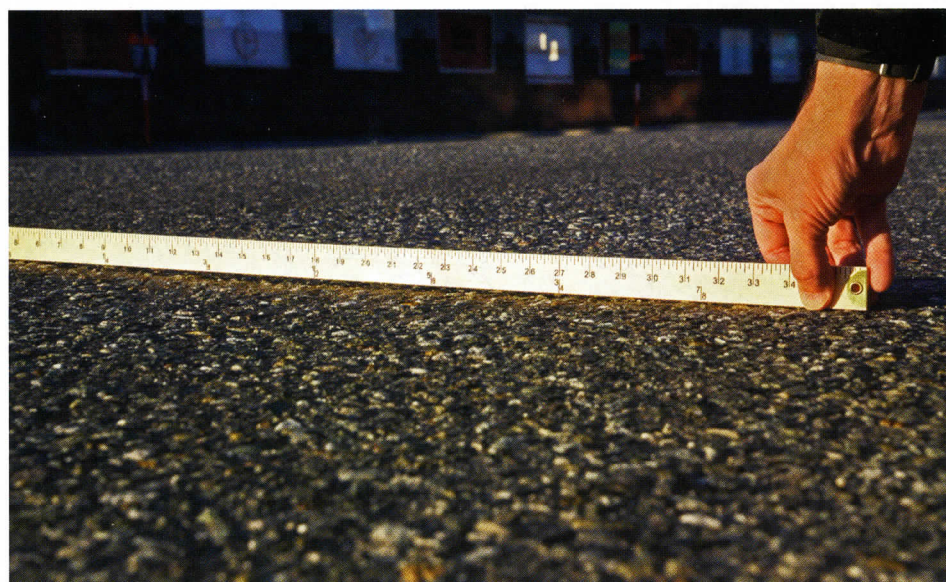
After four winter seasons (2015-2019), the 200 block of E 5th Avenue with HIMA-modified PG64E-40 binder shows minimal rutting.

In 2015, a PG64E-40 HiMA binder was used in a Superpave mix that incorporated hard aggregate. HiMA mix was placed on two busy, one-way streets in downtown Anchorage. This project was a standard street resurfacing with a 1 ¾-inch (44-mm) mill and 2-inch (50-mm) fill. The HiMA overlay was placed on 5th and 6th Avenues and cross

To date, performance has shown minimal damage caused by studded tire wear or traffic loads. In 2019, after four years of traffic, including studded tires, the average rut depths were 0.204 inches (5.2 mm) on 5th Avenue and 0.198 inches (5.0 mm) on 6th Avenue in downtown Anchorage.

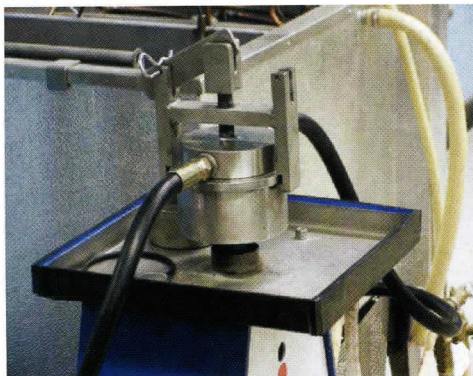
Alaska DOT&PF's Prall tester for studded tire damage

Lab tests confirm these performance properties, Kluttz said. The Prall test, Alaska Test Method 420, for studded tire damage was originally developed in the Nordic countries and is standardized as EN12697-16 in the European Committee for Standardization (hence the standard SI units). Test specimens are 100 millimeters (3.9 inches) in diameter and 30

mm (1.2 inches) thick and are tested at 5 degrees C (41 degrees F). The specimen is loaded in the test device and covered with 40 stainless steel spheres 12 mm (0.47 inches) in diameter. The test chamber is oscillated with a stroke of 43 mm (1.7 inches) at a frequency of 950 strikes per minute for a period of 15 minutes.

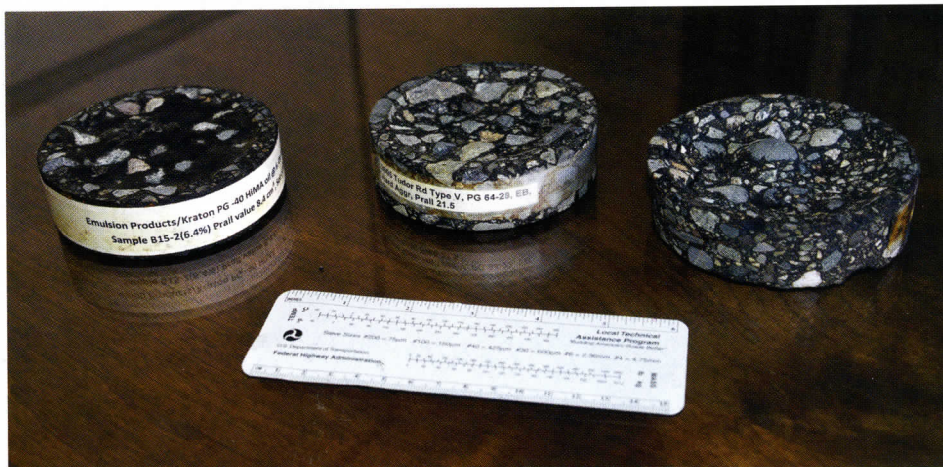
The standard Prall test specimen on the right shows typical abrasion with most of the aggregate clearly visible. The Prall test steel spheres progressively wear the binder and fine aggregate from the specimen surface. With the PG64E-40 HiMA binder specimen at left, much less of the surface is abraded due to its resilience, thus it can continue to protect the aggregate below from fracture.

"What we saw with Prall testing was that the conventional material core sample has a lot of material removed," Kluttz said. "Large aggregate is pretty much all you see. The studs pick out small aggregate and binder, expose the large aggregate, and eventually that fractures and comes out. Then very quickly, the studs pick out more asphalt and fines in mastic."

"But with the HiMA sample, what you see is mostly asphalt," he said. "The test picked out some of the mastic and some of the large aggregate, but what remains is exposed asphalt that is just tougher. It's tough enough to resist being picked up by the studs."

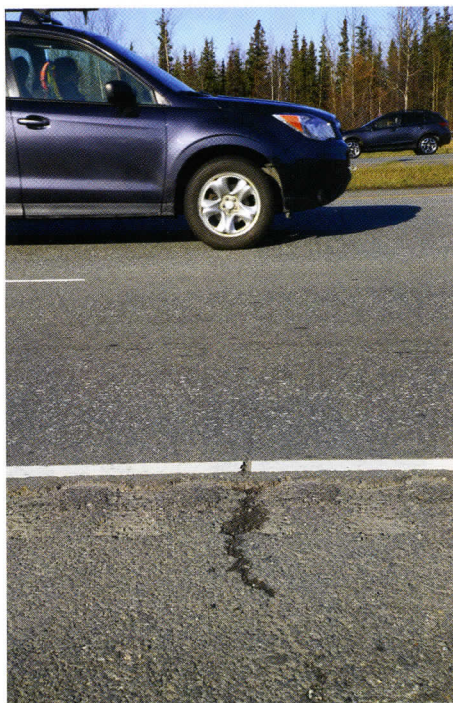
In late 2019, on Glenn Highway, a transverse crack in the shoulder stops at the HiMA pavement, which was placed two years earlier.

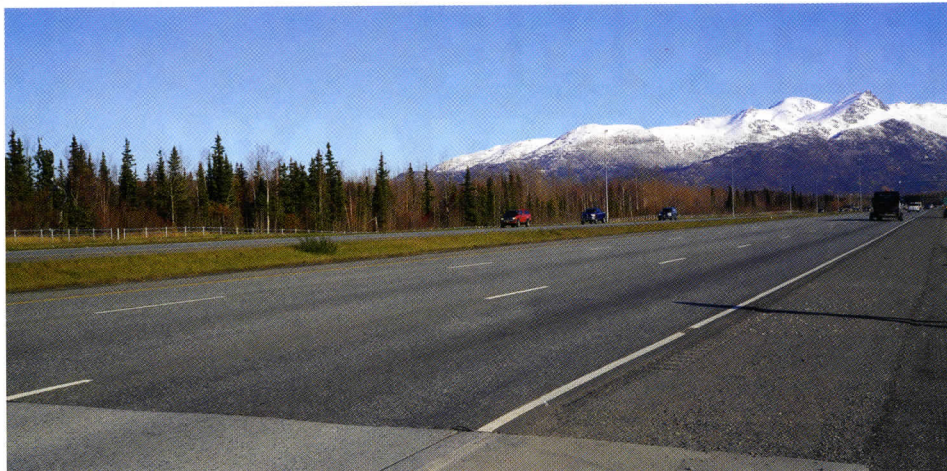
The HiMA mix pavement, eastbound on Glenn Highway Alaska S.R. 1 at a weigh station near Eagle River shows minimal studded tire rutting after two years.

In 2017, the previous mix was milled and replaced with 2 inches (5 centimeters) of HMA, Type VH for resurfacing 15.2 miles (24.5 kilometers) of Glenn Highway. Some 50,000 tons of HMA with PG64E-40 HiMA binder and hard aggregate were placed. In 2019, the average wear on this Superpave mix between Airport Heights and Hiland roads was 0.21 inches (5.3 mm) versus the 0.32 inches (8.1 mm) of crumb rubber asphalt, both after two years of service.
