ALASKA STYMIES STUDDER TIRES

by Tom Kuennen

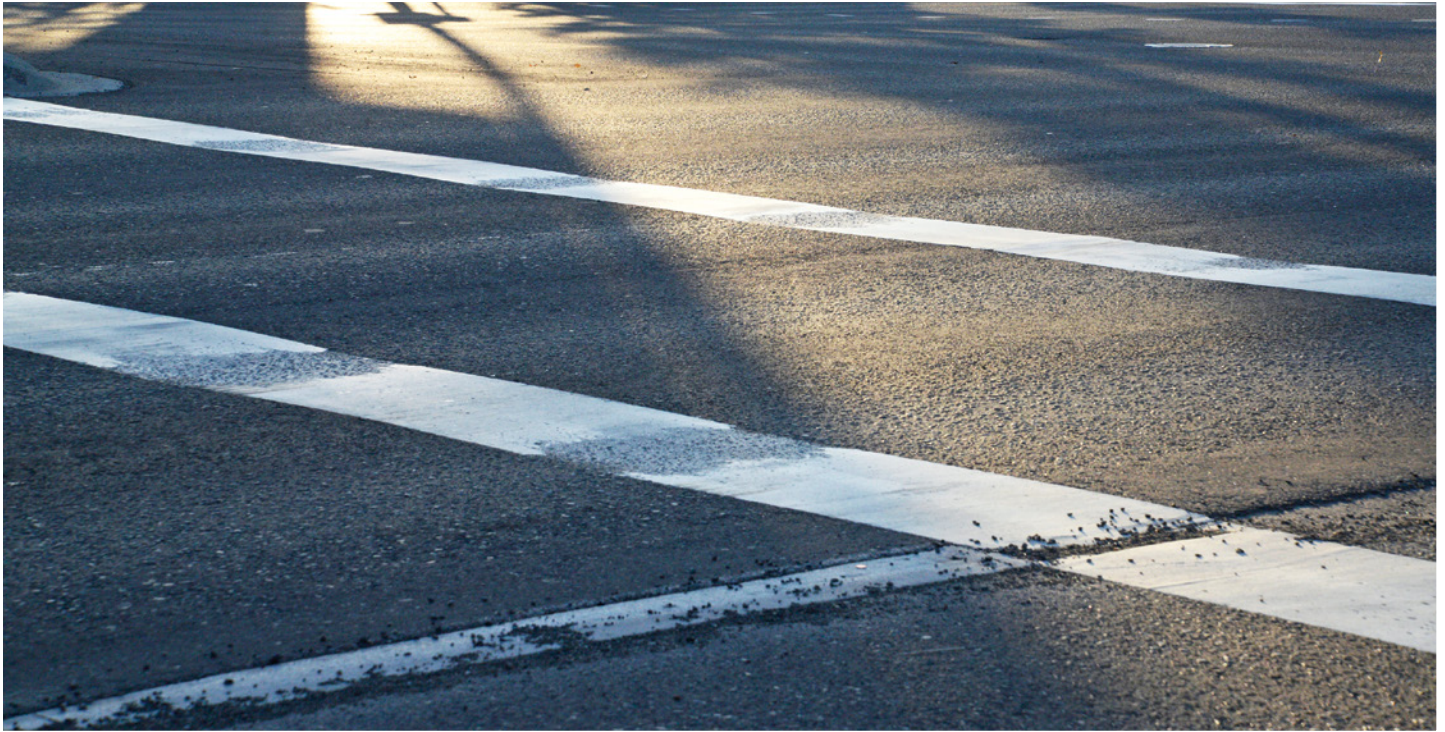
Undulating transverse shadows across rutted pavement -- and gouged intersection striping -- shows rut damage caused by studded tires on Minnesota Avenue in Anchorage

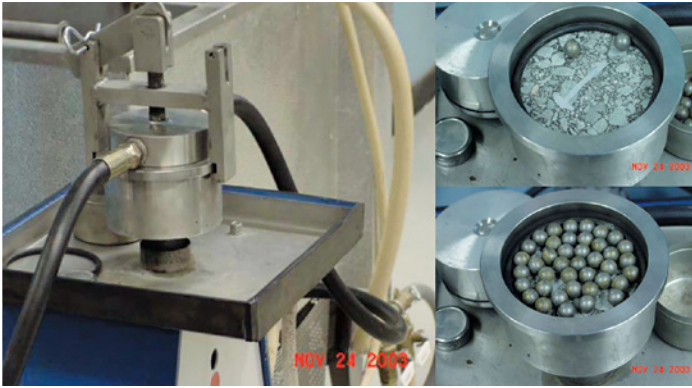
Alaska DOT&PF's Prall tester for studded tire damage

Lab tests confirm these performance properties, Kluttz says. The Prall test, Alaska Test Method 420, for studded tire damage was originally developed in the Nordic countries and is standardized as EN12697-16 in the European Committee for Standardization (hence the standard SI units). Test specimens are 100. mm (3.9 in.) in diameter and 30. mm (1.2 in.) thick and are tested at 5 °C (41 °F). The specimen is loaded in the test device and covered with 40 stainless steel spheres 12 mm (0.47 in.) in diameter. The test chamber is oscillated with a stroke of 43 mm (1.7 in.) at a frequency of 950 strikes per minute for a period of 15 minutes.

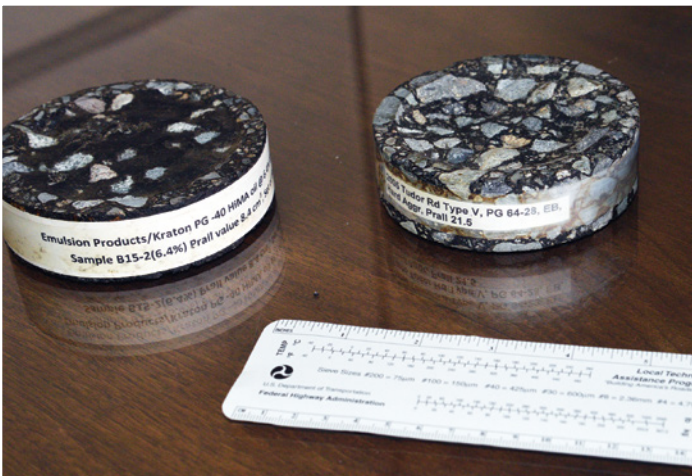
The standard Prall test specimen on the right shows typical abrasion with most of the aggregate clearly visible. The Prall test steel spheres progressively wear the binder and fine aggregate from the specimen surface. With the PG-40 HiMA binder specimen at left, much less of the surface is abraded due to its resilience, thus it can continue to protect the aggregate below from fracture

"What we saw with Prall testing was that the conventional material core sample has a lot of material removed," Kluttz says. "Large aggregate is pretty much all you see. The studs pick out small aggregate and binder, expose the large aggregate, and eventually that fractures and comes out. Then very quickly, the studs pick out more asphalt and fines in mastic."

"But with the HiMA sample, what you see is mostly asphalt," he says. "The test picked out some of the mastic and some of the large aggregate, but what remains is exposed asphalt that is just tougher. It's tough enough to resist being picked up by the studs."

The wheel paths look dark much like the Prall test specimens, indicating that roughly the same behavior is occurring in the laboratory and in the field. The Alaska DOT&PF is pleased with the performance and is specifying more projects with modified PG 64-40 E binder and hard aggregates, designated as Hot Mix Asphalt, Type VH by Alaska DOT&PF.

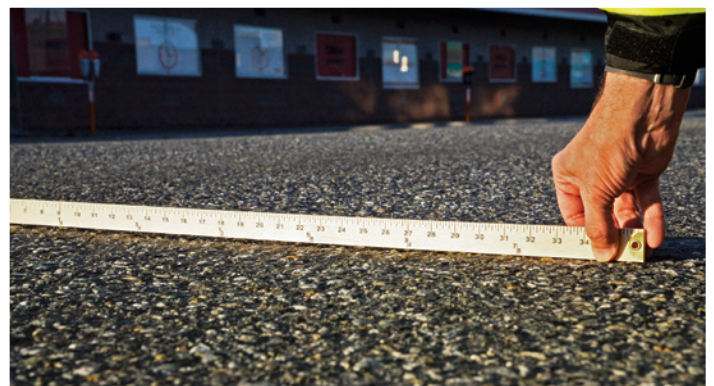
After four winter seasons (2015-2019), 200 block of E 5th Avenue with HiMA-modified PG 64-40 E binder shows minimal rutting

To date, performance has been good with minimal damage caused by studded tire wear or traffic loads. In 2019, after four years of traffic including studded tires, the average rut depths were 0.204 in. (5.2 mm) on 5th Avenue and 0.198 in. (5.0 mm) on 6th Avenue in downtown Anchorage.

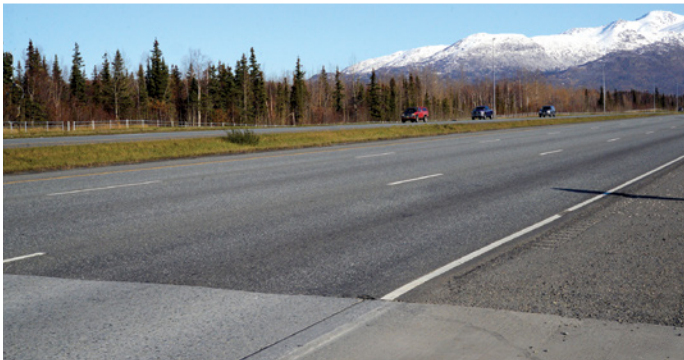
HiMA mix, eastbound Glenn Highway Alaska S.R. 1 at weigh station near Eagle River shows minimal studded tire rutting after two years

In 2017, the rubberized mix was milled and replaced with 2 in. (5 cm) of Hot Mix Asphalt, Type VH for resurfacing 15.2 miles (24.5 km) of Glenn Highway. Some 50,000 tons (45,000 mt) of Hot Mix Asphalt with PG 64-40 E HiMA binder and hard aggregate were placed. In 2019, the average wear on this Superpave mix between Airport Heights and Hiland roads was just 0.21 in. (5.3 mm) versus 0.32 in. (8.1 mm) of crumb rubber asphalt, both after two years of service.
