**Diamond grooving and grinding are being used to restore rough or polished concrete pavements to ultrasmooth conditions and quell noise – but at a price.**

## **Grooving, grinding and preservation**

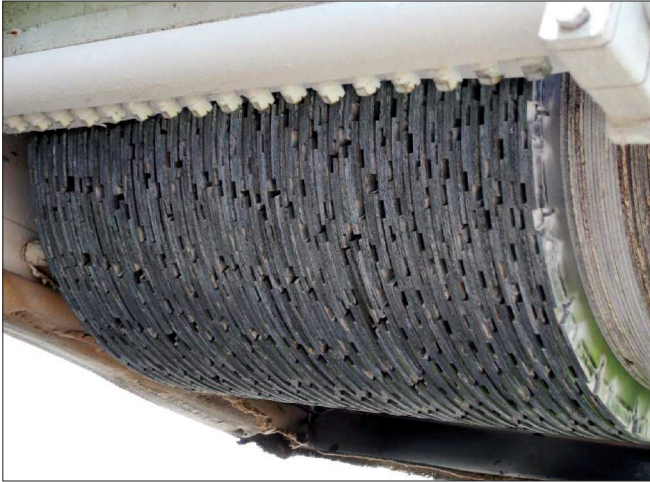
Closely-spaced diamond-coated circular saw blades are at the heart of this self-propelled grooving/grinding machine.

It involves the removal of a thin layer of the cured concrete surface using a dedicated, self-propelled machine with closely-spaced diamond-coated circular saw blades. Diamond grinding restores rideability by removing surface irregularities. The immediate effect of diamond grinding is a significant improvement in the smoothness of a pavement, and a substantial increase in surface macrotexture with improvement in skid resistance, noise reduction and safety.

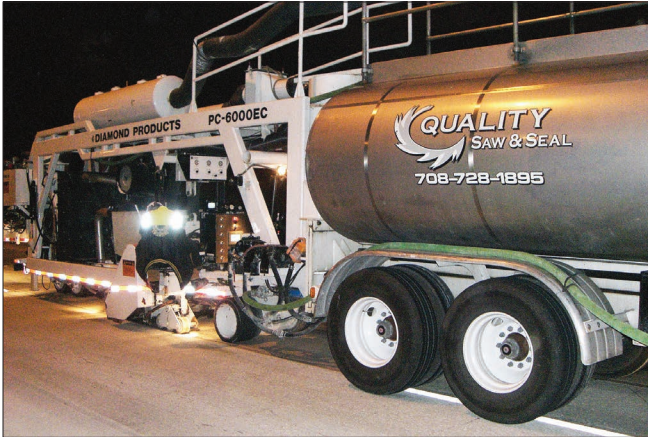
Ames Engineering of Ames, Iowa, conducted profile testing of three lanes in both directions of Chicago's I-290, the Eisenhower Expressway, between Austin Avenue and Sacramento Boulevard after diamond grinding (as shown here) was done in 2010. The profile testing was conducted to compare the stone matrix asphalt ride qualities with those of the conventional diamond-ground pavement.

Recently, Ames Engineering of Ames, Iowa, conducted profile testing of three lanes in both directions of I-290 between Austin Avenue and Sacramento Boulevard. The profile testing was conducted to compare the SMA ride qualities with those of the conventional diamond-ground pavement.

The research found that the diamond-ground surface had an overall average profile index (zero blanking band) of 20 inch/mile with a standard deviation of 3.9 inch/mile, while the SMA exhibited an overall average of 23.1 inch/mile and a standard deviation of 6.3 inch/mile. While 90 percent of the diamond-ground surface exhibited a profile index of 25 inch/mile or less, only 61 percent of the SMA surface achieved this. Additionally, while 100 percent of the diamond-ground surface can meet a requirement of 30 inch/mile, 10 percent of the SMA surface still would exceed this limit.

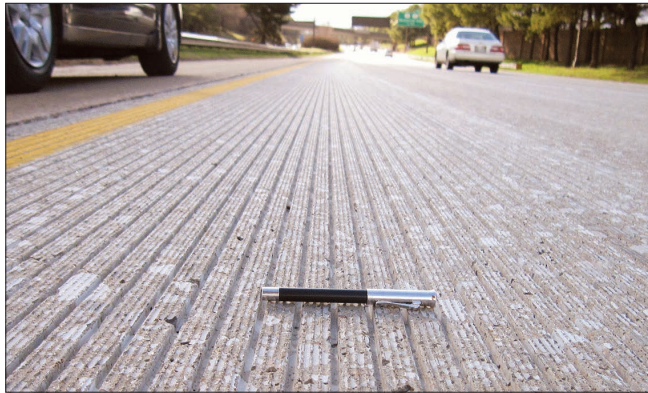
I-440 concrete pavement preservation project near Nashville included 350,000 square yards of diamond grinding and grooving.

The project included 10,000 square yards of pavement replacement, 2,000 square yards of spall repair, 350,000 square yards of diamond grinding and grooving, and 450,000 linear feet of joint cleaning and resealing.
