HIMA OFFERS RESULTS ON I-40

The pavement on a section of Interstate 40 incorporates highly modified asphalt (HiMA) made using Kraton polymers in three different asphalt mixes and lifts. It features enhanced durability with a thinner cross-section of pavement than is typical for Oklahoma interstates. A low viscosity polymer allows the use of 7.5 percent styrene-butadiene-styrene (SBS) polymer.

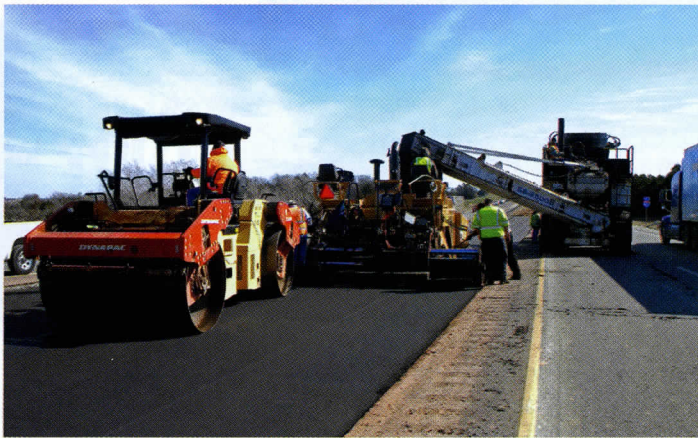
In 2012, Haskell Lemon offset a material transfer vehicle to ensure high quality placement of HiMA asphalt lifts.

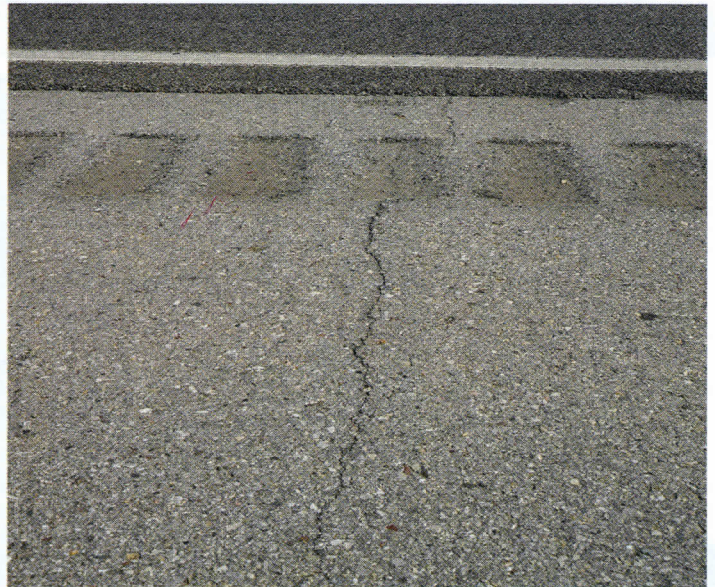
A transverse crack halts at the interface with 8-inch HiMA-modified pavement structure.
